## 1 Scope and field of application

This report presents an environmental analysis of the Martex Spa which was carried out in order to evaluate the company's environmental impact.

The activities carried out by Martex Spa are the design, production and sales of office furniture.

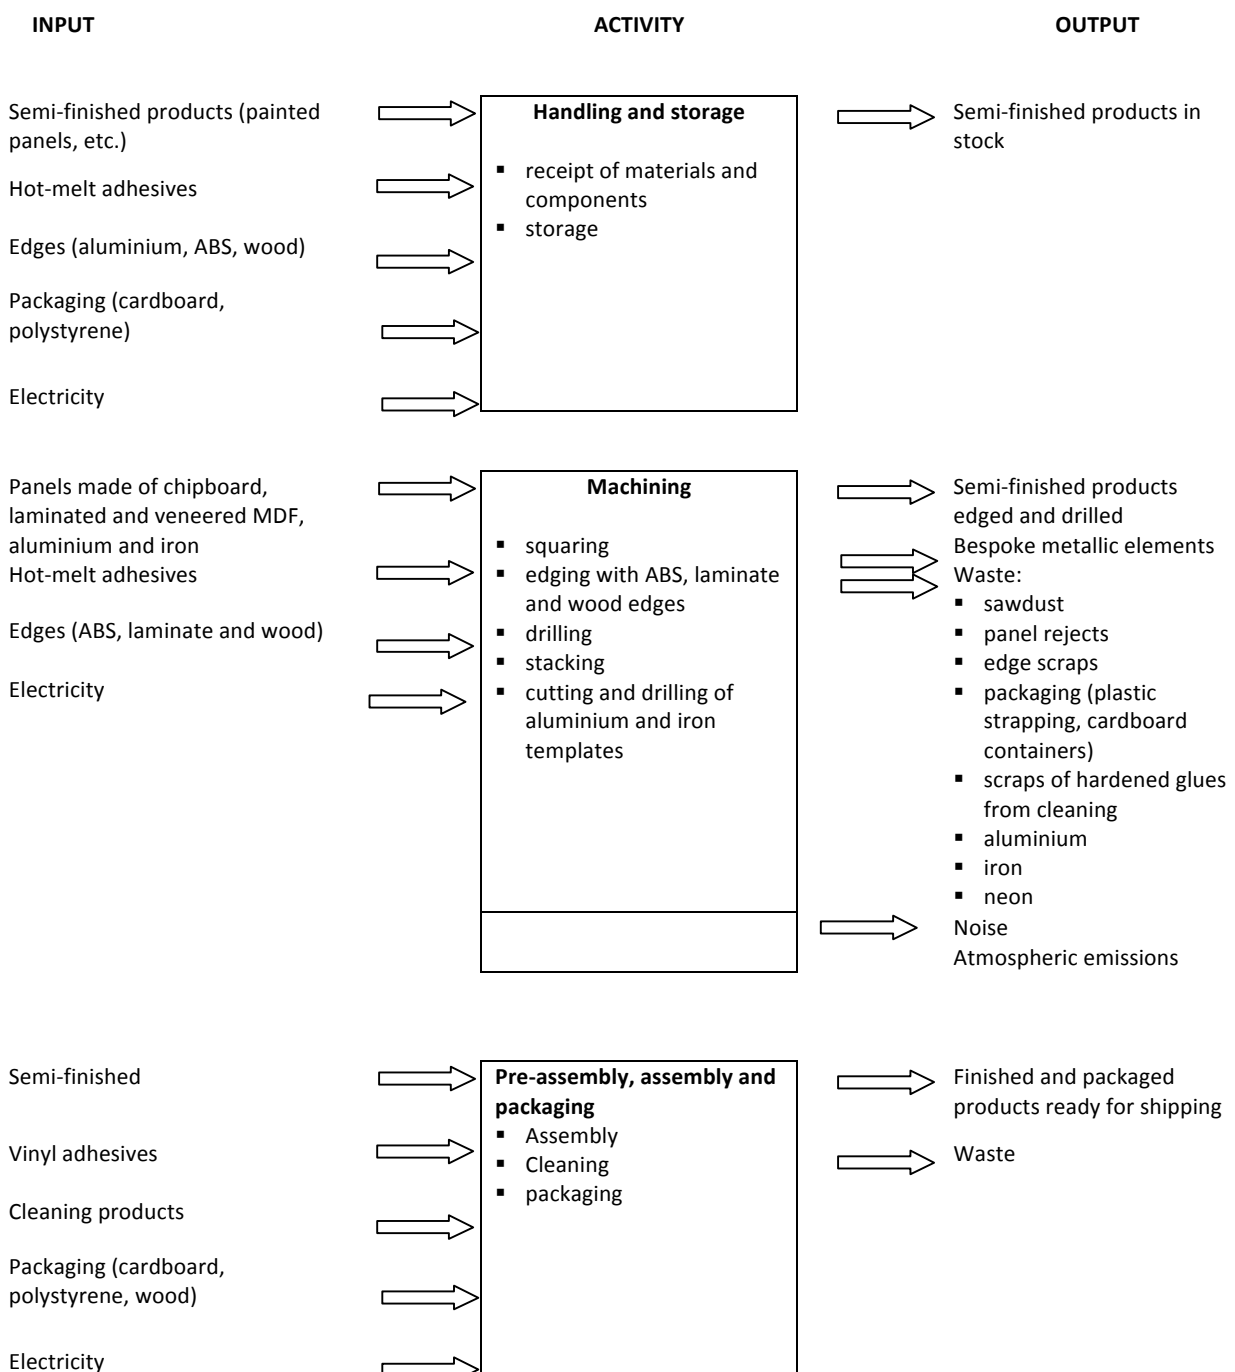
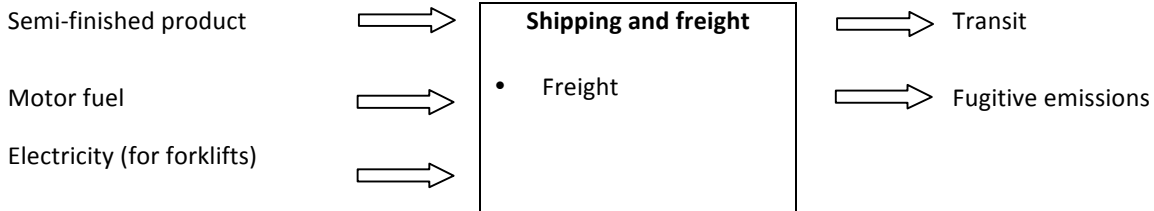
The following is a diagram of the production cycle with the input and output elements.

The Via Sagree production cycle consists of an assembly line divided into sections:

1. **Handling and warehousing:** reception of components and semi-finished products and their storage.

2. **Machining:** construction of furniture and prototypes with the use of circular saws, a single-shoulder edge banding machine, pantograph, spindle moulder, drilling machines, trimmer and clamps. Cutting and drilling of aluminium and iron templates.
3. **Pre-assembly, assembly and packing:** assembly, cleaning and packing operations.
4. **Shipping and freight:** the freight plans are prepared for the client and destination; freight is the shipping of goods.

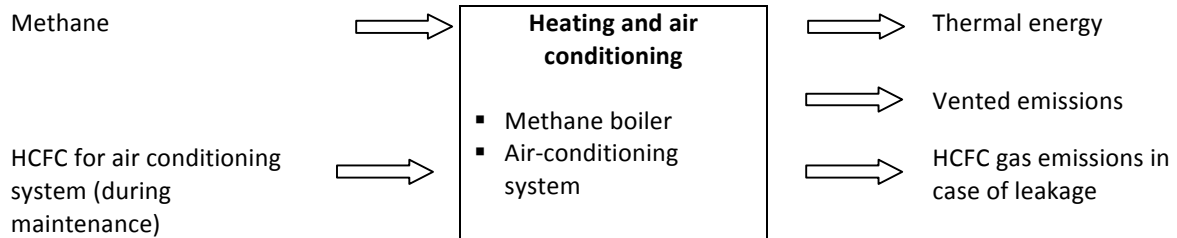
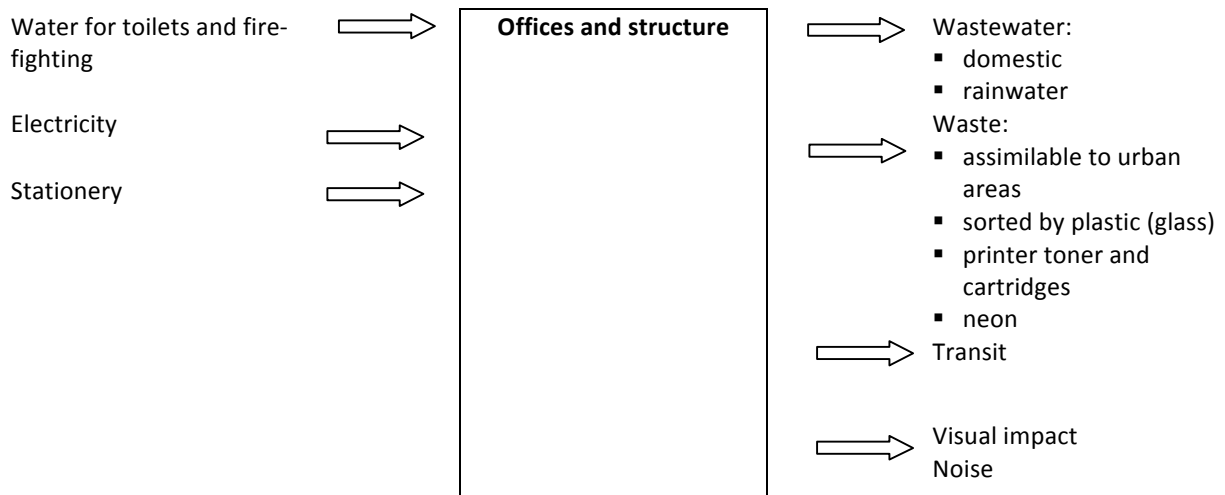
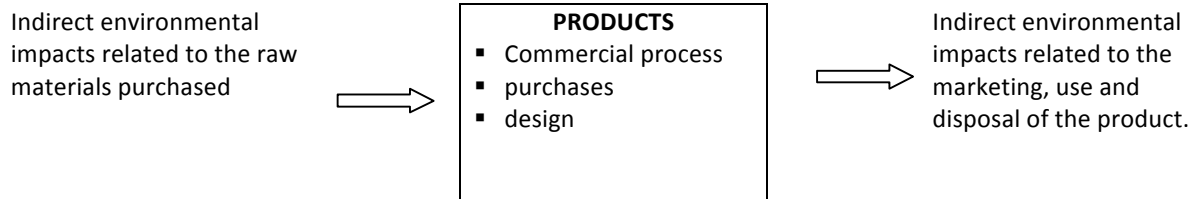
In addition to the production cycle phases, we considered the general input and output of the site derived from the auxiliary activities and from the structure.
